5.9 Roof Technical Guidelines

5.9.1 INTRODUCTION

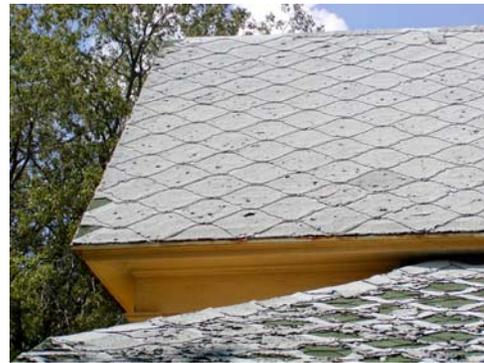
**OLDER 'DIAMOND' PATTERN
COMPOSITION ROOF w/ AREAS OF
FAILURE**
